SUBJECT: AFCEE ENRAC F41624-01-D-8545; Task Order 0071
MMR SPEIM/LTM/O&M Program
CDRL #A012
**Ashumet Pond Geochemical Barrier for Phosphorus Removal Installation
Summary Report**

Ashumet Pond Geochemical Barrier for Phosphorus Removal Installation Summary Report

March 2005

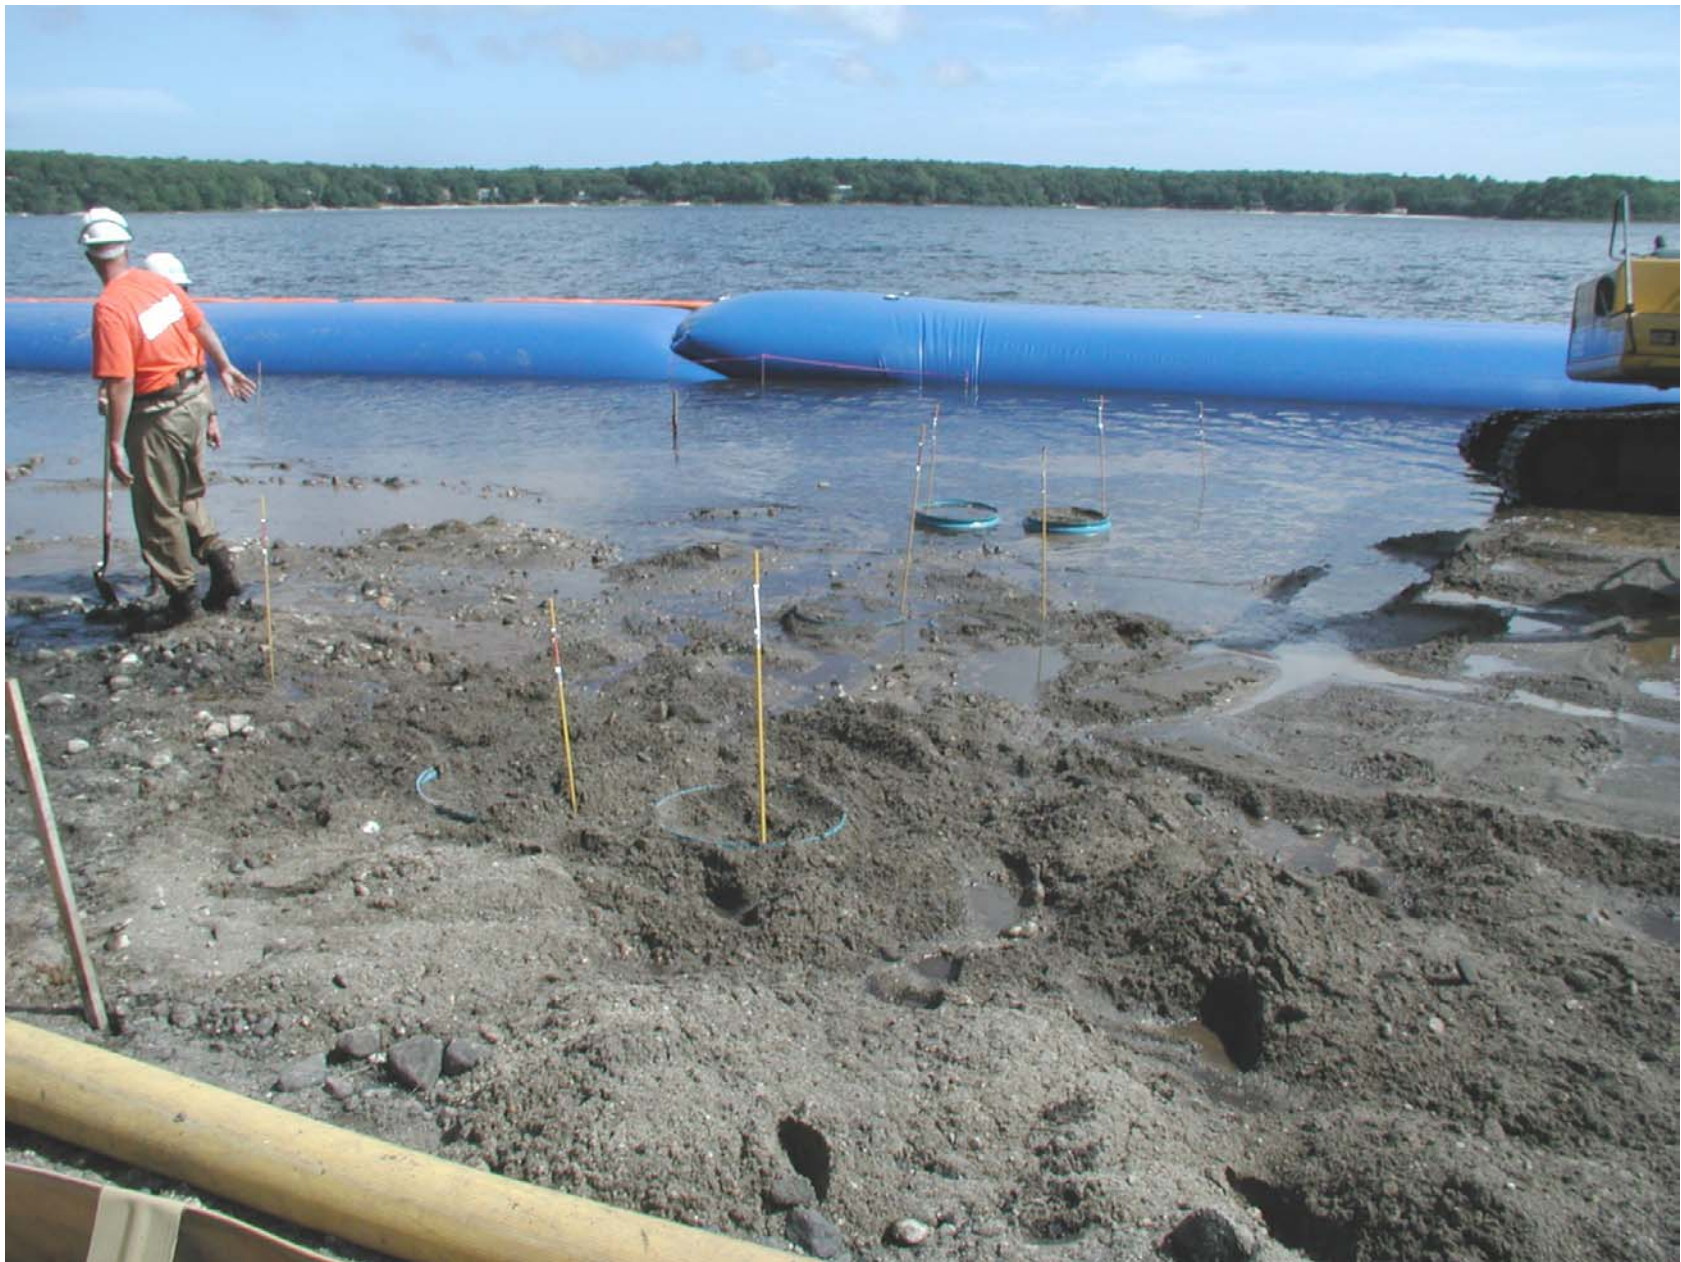
FIGURE 17
Seepage Meters – Installed
